Internal Drainage Board (IDB) daily update – January 2025

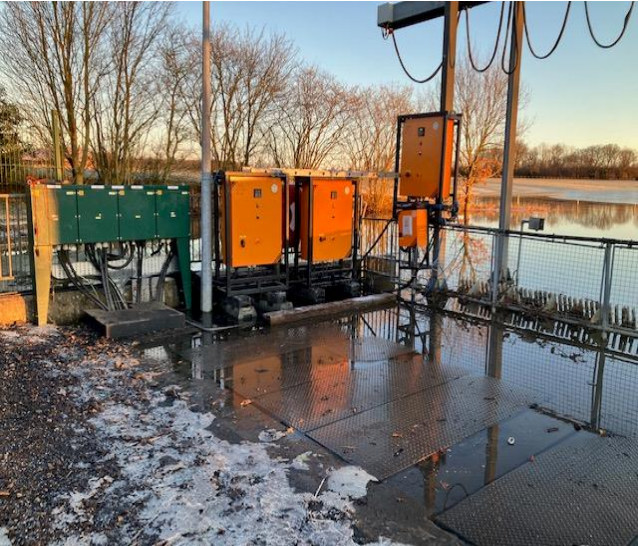
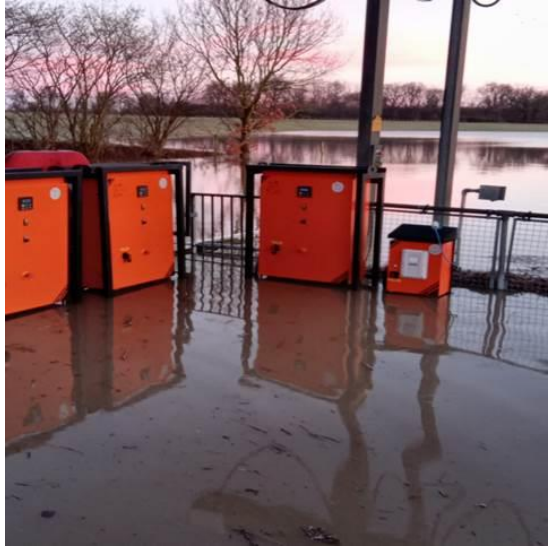
I (Nathan) have been at Stillingfeet pump station since early this morning as we had a problem with one of the assisting pumps however this is now all re-set and back in action. The water level at the station has fallen by 300mm and as predicted with the river now falling below 5 meters AOD water is discharging out of the gravity flapvalves therefore we will continue to see falling water levels throughout today and a big improvement.

Pictures below that I took this morning within compound area at the station compared to the water level picture taken on Tuesday Morning of this week – as you will note the electrical panel to the right I had to elevate higher so water did not ingress and knock the whole system out.
